**Installation Restoration Program
Phase II - Confirmation/Quantification
Stage 1**

Seymour Johnson Air Force Base, NC 27531

July 1985

Prepared by
Center for Environmental Measurements
Research Triangle Institute
Research Triangle Park, NC 27709

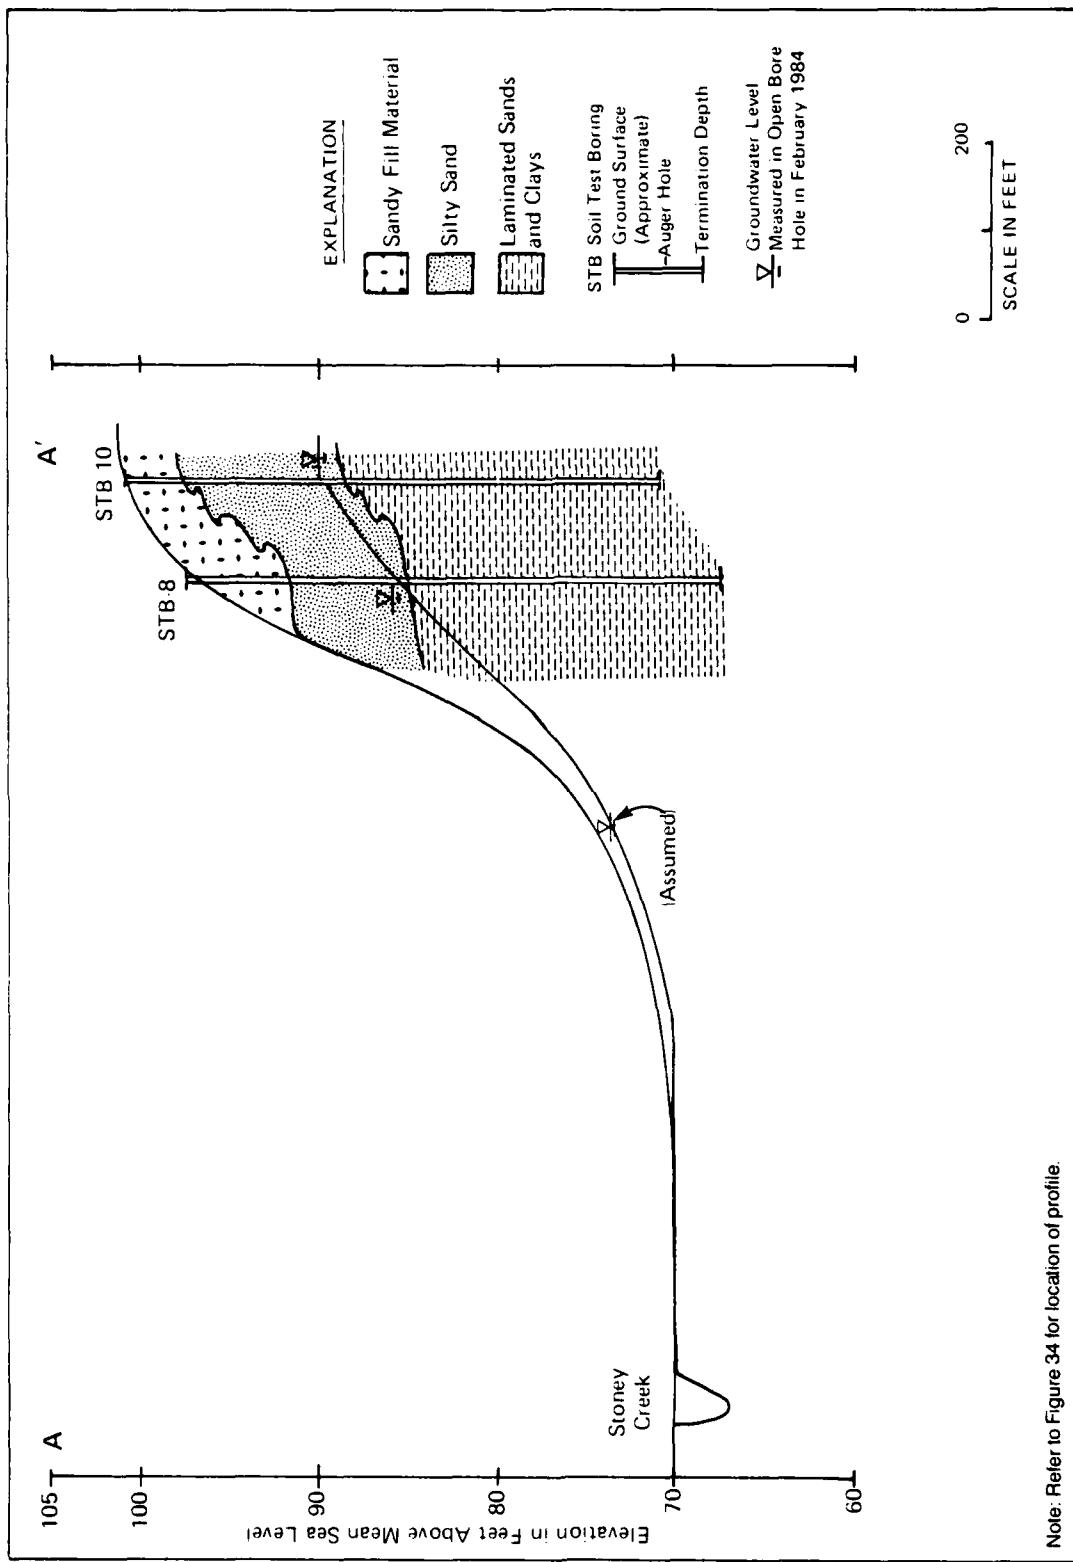
Figure 35. Inferred hydrogeologic profile A-A' (Site 7).

The results of the soil analyses are provided in Appendix H, Table H-7. No pesticides were detected in the soils. In the analyses of lead, chromium, and oil and grease in the soils, the results from boring STB-10 appear to represent background soil conditions (Appendix H, Table H-7). The concentration of lead did not exceed 3 $\mu\text{g/g}$, chromium did not exceed 7 $\mu\text{g/g}$, and oil and grease was below detection limits in boring STB-10. Based on these levels, it is apparent that the concentrations of lead and chromium measured

within the upper 3 feet of soil collected from boring STB-8 (676 and 71 $\mu\text{g/g}$, respectively) are significantly above background levels. These results may be associated with the yellow substance previously noted that was observed in the fill material at this same depth in boring STB-8. The yellow substance may simply be a local concentration of paint in the fill materials. Some of the metals analyzed in borings STB-7 and STB-9 were also elevated significantly above background levels (Appendix H, Table H-7).

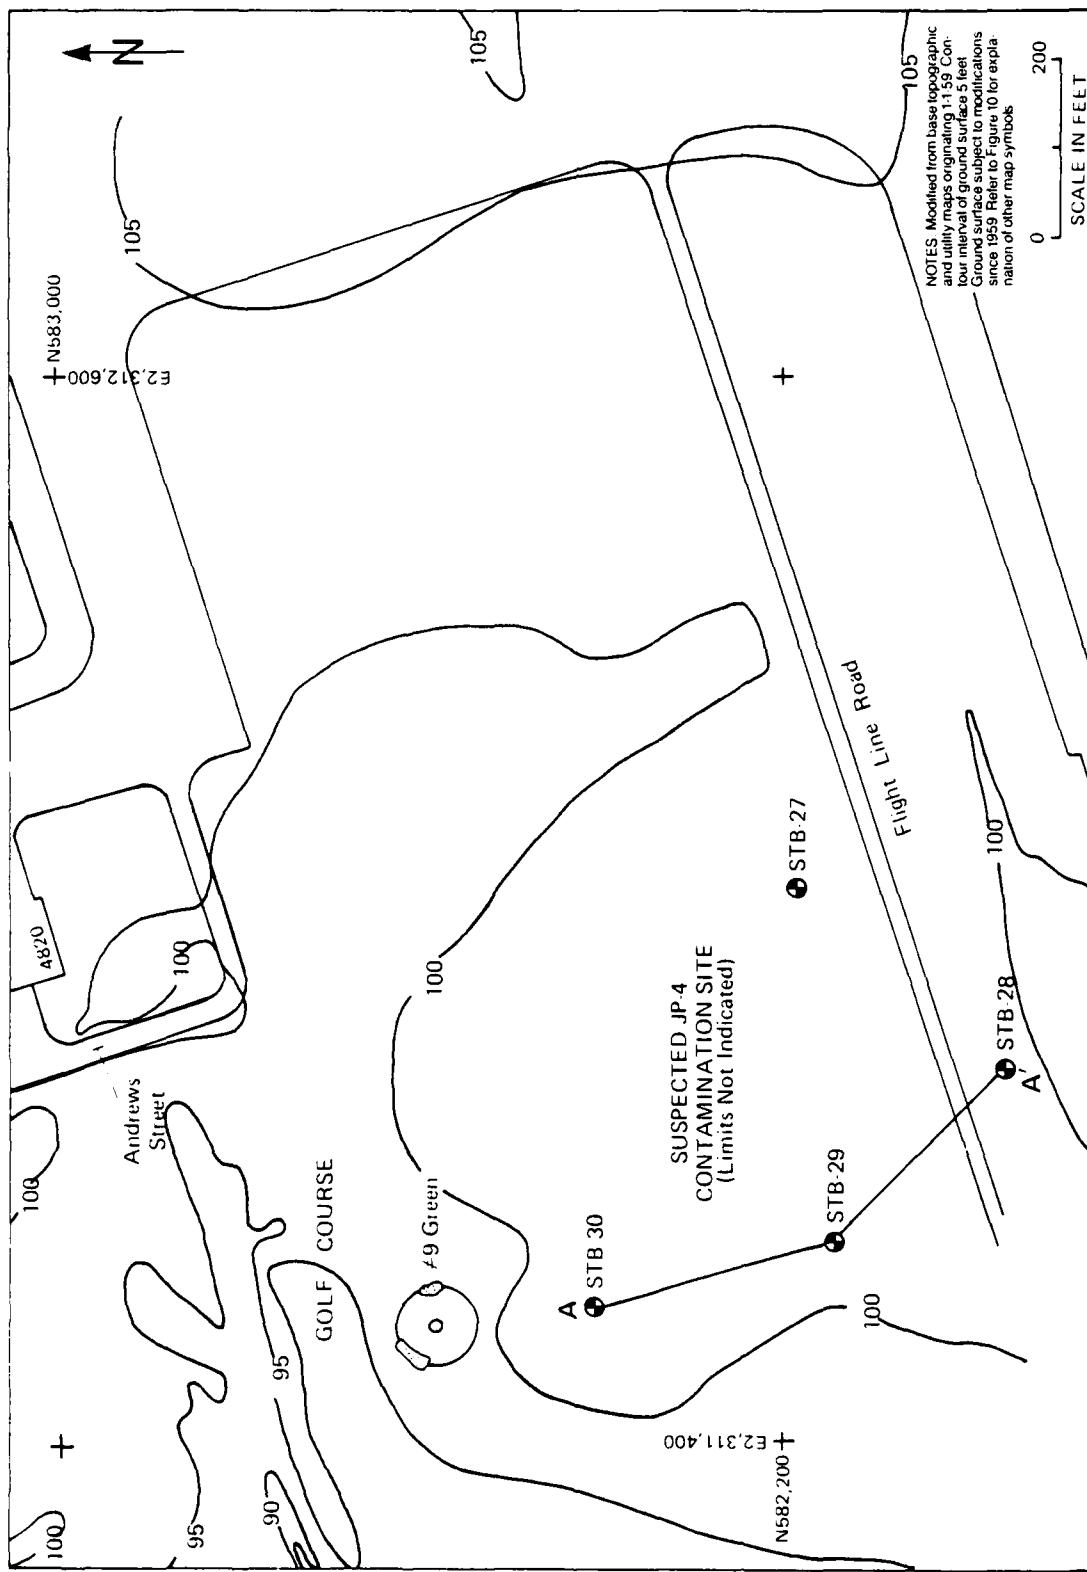
Figure 36. Topographic setting of Site 8 with location of profile A-A'.

The general topographic setting of Site 8 is indicated in Figure 36 along with the location of an inferred hydrogeologic profile. The site is generally flat-lying with a drainage ditch to the northwest.

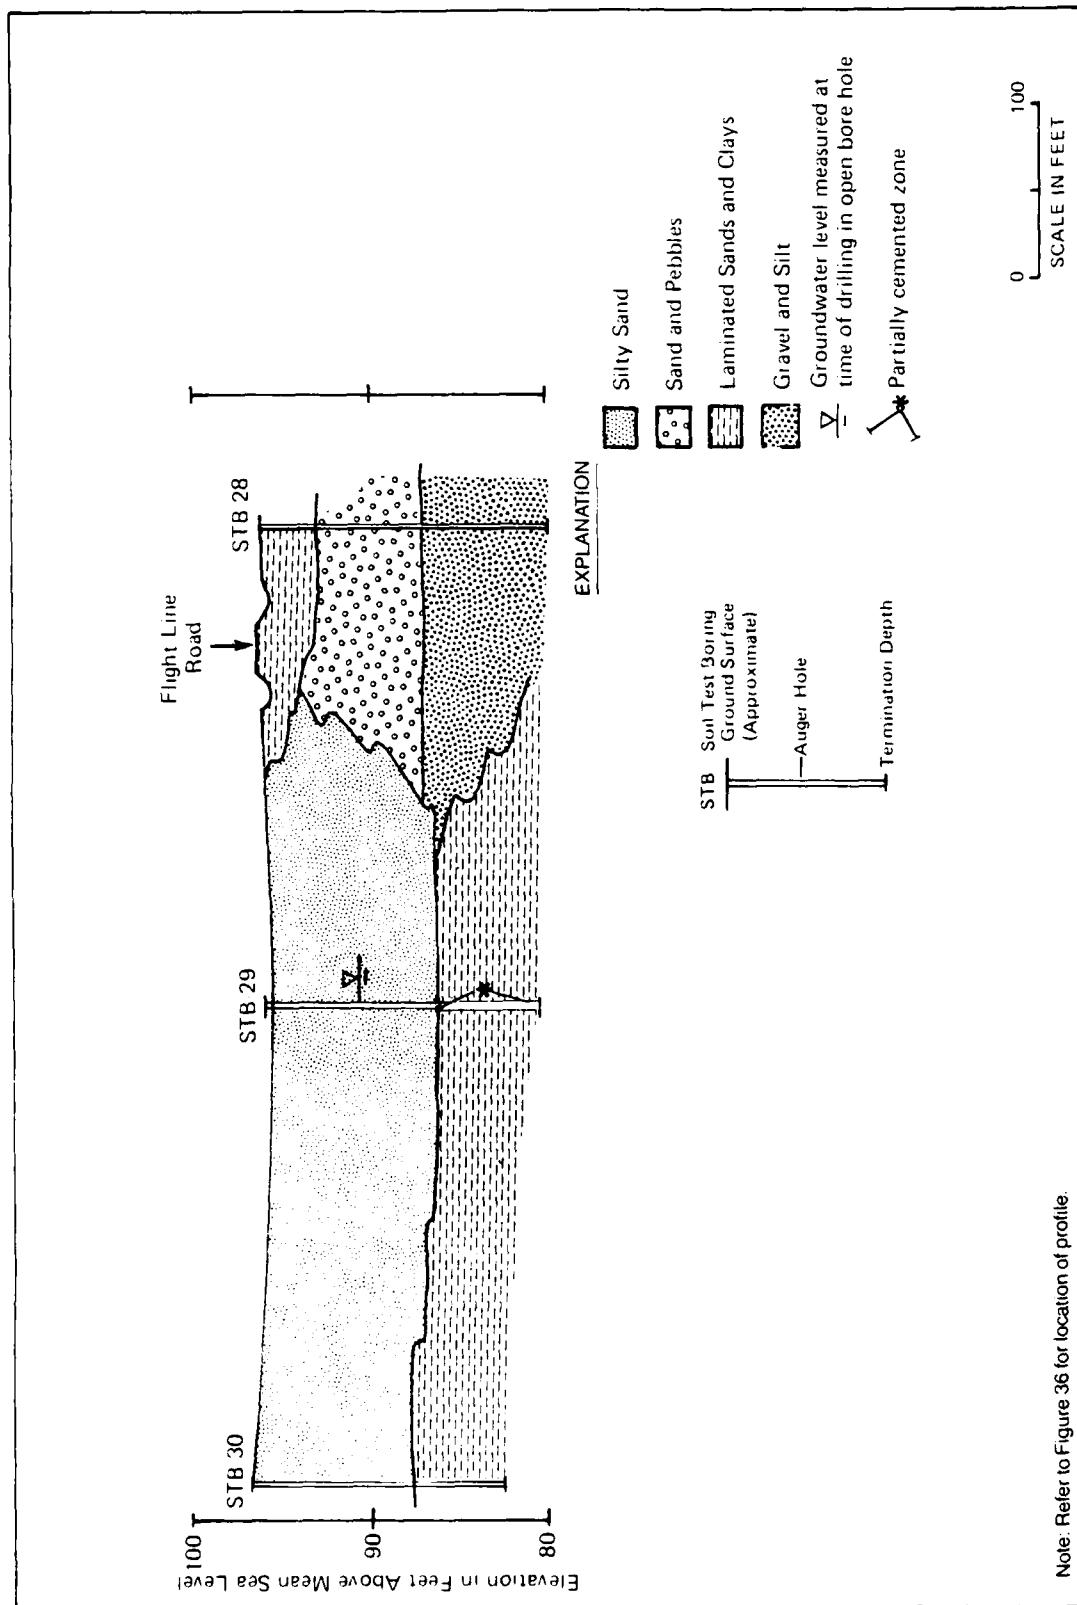
Figure 37. Inferred hydrogeologic profile A-A' (Site 8).

Four soil test borings were drilled at the site to depths of about 15 feet. Soil samples were retained for analysis, but no monitoring wells were installed. Soil test borings STB-28, STB-29, and STB-30 were used to construct an inferred profile of subsurface conditions. The subsurface conditions between borings STB 29 and STB 30 are similar (Figure 37). Silty sands overlie a silty clay stratum at an average depth of about 9 feet. This clay stratum may represent the top of the Black Creek forma-

tion. On the basis of one groundwater measurement collected at the time of drilling, the water table is estimated to occur at a depth of between 4 and 5 feet below land surface and is within the sand strata. The deposits transition into a gravel-bearing sequence south toward boring STB-28 (Figure 37).
